# Corrosion mitigation of photovoltaic ribbon using a sacrificial anode

## 희생양극을 이용한 태양광 리본의 부식 저감

**Abstract** Degradation is commonly observed in field-aged PV modules due to corrosion of the photovoltaic ribbon. The reduced performance is caused by a loss of fill factor due to the high series resistance in the PV ribbon. This study aimed to mitigate the degradation by corrosion using five sacrificial anodes - Al, Zn and their alloys - to identify the most effective material to mitigate the corrosion of the PV ribbon. The corrosion behavior of the five sacrificial anode materials were examined by open circuit potential measurements, potentiodynamic polarization tests, and galvanic current density and potential measurements using a zero resistance ammeter. Immersion tests for 120 hours were also conducted using materials and damp heat test tests were performed for 1500 hours using 4 cell mini modules. The Al-3Mg and Al-3Zn-1Mg sacrificial anodes had a low corrosion rate and reduced drop in power, making then suitable for long-term use.

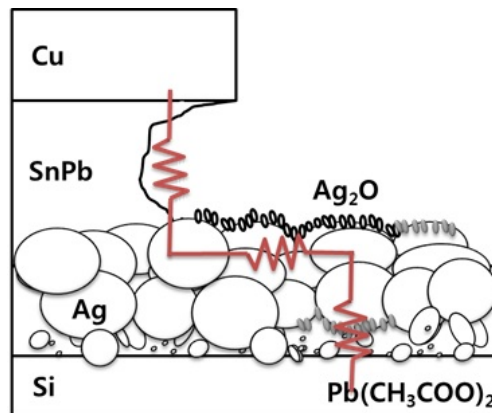
Fig. 1. Reported degradation mechanisms

several years; this was because of the fill factor (FF) loss due to an increase in the series resistance ( $R_s$ ) induced by the early degradation or failure of the interconnector [2]. The reported corrosion mechanisms (Fig. 1.) of the Ag electrode and SnPb solder are as follows:

- (1) Following the reaction between  $Pb^{2+}$ , as an additive in the silver paste, and  $CH_3COO^-$ , which is decomposed in the ethyl vinyl acetate (EVA),  $Pb(CH_3COO)_2$  is formed at the top of the Ag finger and at the interlayer between the Ag and Si [3,4].
- (2) A  $Ag_2O$  layer is formed on the surface of the Ag finger, resulting in the line resistance of the Ag finger [5].
- (3) The SnPb in the PV ribbon dissolves because of galvanic corrosion, which occurs because of the potential difference between the Ag and PV ribbon [6].
- (4) The bulk Ag and crystallites at the edge of the Ag finger are oxidized by the thermal and humidity stress.

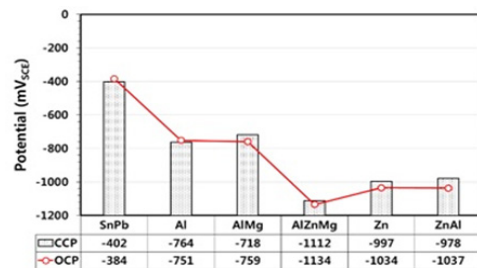
Fig. 2. OCP and CCP of samples in 0.1 M NaCl

Fig. 2 shows the OCP measurement results for the Sn36Pb2Ag, pure Al, Al-3Mg, Al-3Zn-1Mg, pure Zn, and Zn-0.5Al samples, following their immersion in a deaerated 0.1 M NaCl solution for 10 min. The Al-3Mg sample moved towards the positive potential during the initial stage of immersion because of the formation of an oxide film (MgO). Owing to the

formation of an Al<sub>2</sub>O<sub>3</sub> layer, the Al sample also exhibited a higher potential than that of the standard hydrogen electrode (SHE) (1.66 VSHE). The Al-3Zn-1Mg affects the behavior of the passive Al, because it has a higher electronegative potential than pure Al. The corrosion potential of the pure Zn and Zn-0.5Al demonstrated similar results. Following the OCP measurements, potentiodynamic polarization tests were conducted by potential sweeping to obtain the CCP measurements.

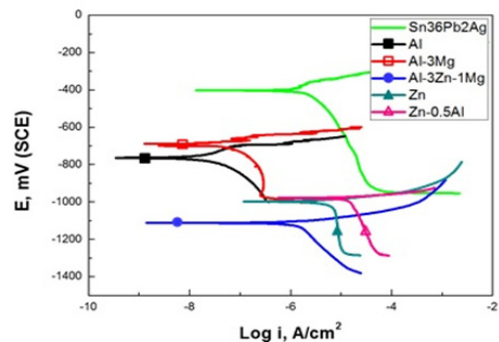
Fig. 3. Potentiodynamic polarization curves of samples in 0.1 M NaCl

Fig. 3 presents the potentiodynamic polarization curves of the samples. The OCP and CCP results correlate well. From the OCP and CCP results, it can be determined that the pure Zn and Zn-0.5Al have similar corrosion potentials. However, the current density of the Zn-0.5Al alloy is greater than that of the pure Zn.

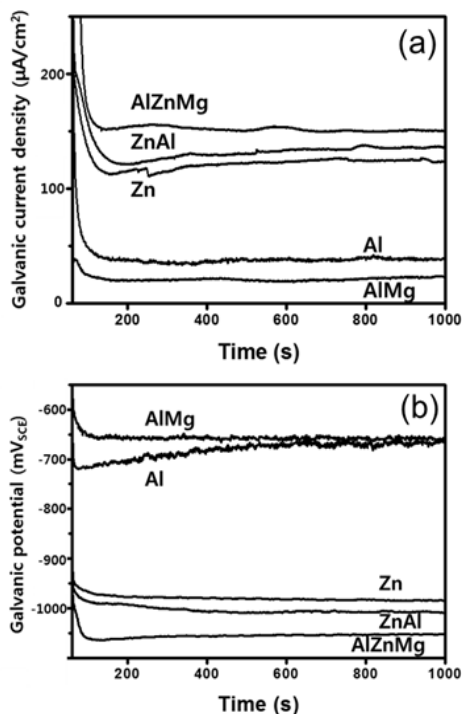
Fig. 4. (a) Galvanic current density and (b) galvanic potential between sacrificial anodes and SnPbAg

Fig. 4 shows the results for the galvanic current density, galvanic potential, and corrosion rate. The values calculated from the intersection of the potentiodynamic polarization curve were compared with those measured by the ZRA technique. The corrosion rate was calculated using Eq.1, using the results obtained from the ZRA measurements. For the sacrificial anode material to be suitable for long-term use, there should be a relatively large corrosion potential difference (low corrosion potential) between the SnPb solder and the sacrificial anodes.

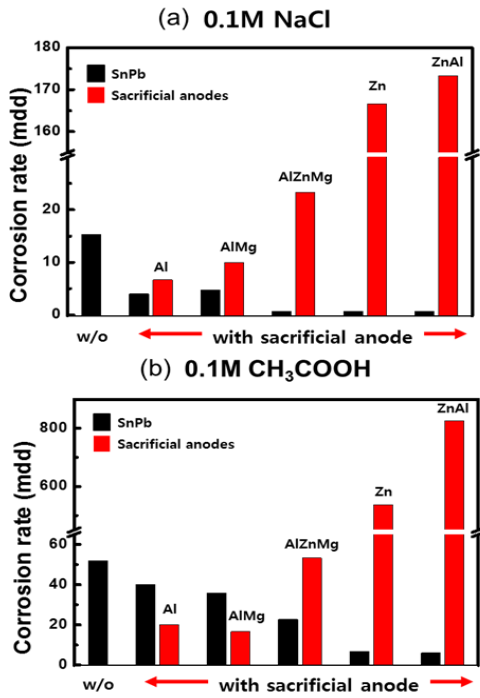
Fig. 5. Corrosion rates following the immersion test with galvanic coupling in 0.1 M NaCl(a) and 0.1 M CH<sub>3</sub>COOH(b) for 120 h (mdd = mg/100 cm<sup>2</sup>/day)

Fig. 5 shows the corrosion rates calculated using the mass loss that occurred following the immersion test. The Zn and Zn-0.5Al anodes are unsuitable for long-term use because of their high corrosion rate. The Al-3Zn-1Mg anode appears to have a satisfactory corrosion rate and the consumption of SnPbAg is low with its use.

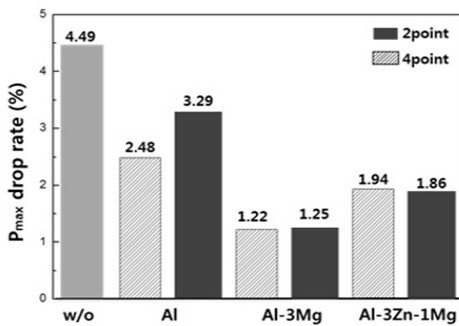
Fig. 6. P<sub>max</sub> drop rate following the DH test

Fig. 6 indicates the results of the P<sub>max</sub> drop rate that were obtained from the DH test (95 °C/95% RH, 1000 h) performed on the 4-cell mini-modules. 2- and 4-point sacrificial anodes consisting of Al, Al-3Mg, and Al-3Zn-1Mg were applied at the ends of the PV ribbon. Compared to its initial value, the mini module without the sacrificial anode presented a P<sub>max</sub> drop rate of 4.5%. The samples with the sacrificial anodes showed a reduction in the P<sub>max</sub> drop rate.

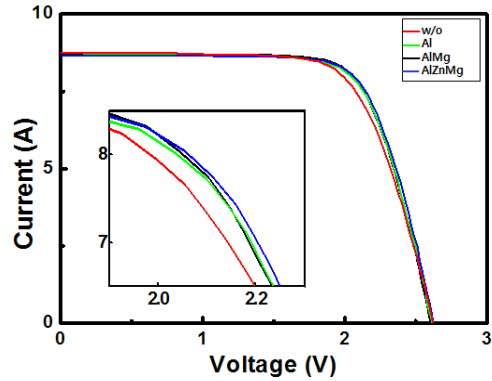
Fig. 7. I-V parameters following DH testing for 1500 h

Fig. 7 and table 1 show the light I-V parameters following a period of 1500 h. The FF loss via the R<sub>s</sub> increase was reduced for the samples with the sacrificial anodes.

Table 1. I-V parameters of Fig. 7.

Samples	P <sub>max</sub> (W)	I <sub>sc</sub> (A)	V <sub>oc</sub> (V)	FF(%)	R <sub>s</sub> (mΩ)
W/O	16.1	8.80	2.62	69.8	52.2
Al	16.5	8.77	2.62	71.7	48.8
AlMg	16.6	8.80	2.61	72.4	46.7
AlZnMg	16.7	8.74	2.63	72.6	46.7
